Lake Therese Dam (NJ-00349). Raritan River  
Basin, McVickers Brook, Morris County,  
New Jersey. Phase 1 Inspection Report.

LAKE THERESE (NJ00349)

CORPS OF ENGINEERS ASSESSMENT OF GENERAL CONDITIONS

Assessment of General Condition of Dam

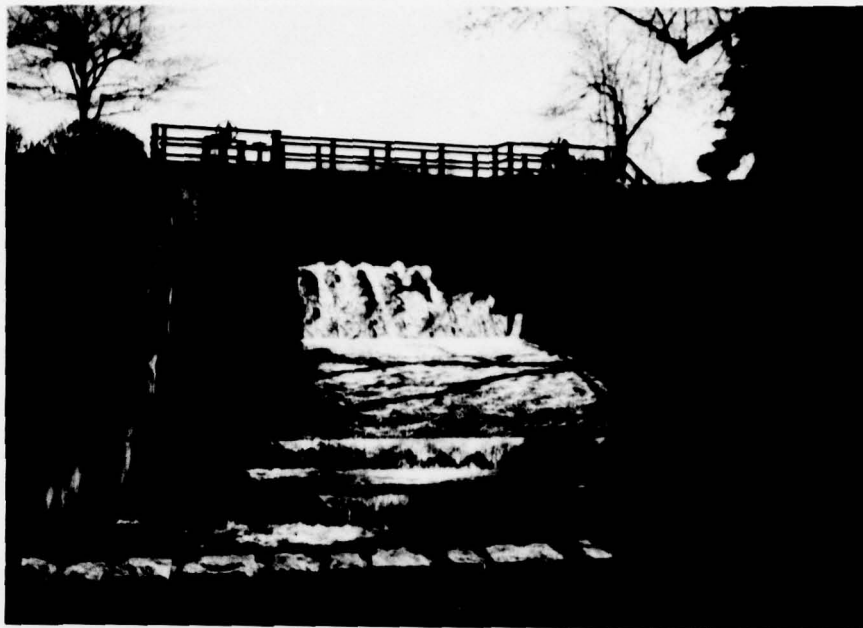
The training walls of the spillway continue as retaining walls for the discharge channel. The concrete apron and retaining walls are in good condition. The ogee portion of the spillway and the flashboards and gates appeared to be in generally good condition. Some leakage was observed at the side of the south radial gate. The leakage appeared to be caused by localized spalling of the concrete surface adjacent to the gate and deterioration of the rubber seal along the edge of the gate.

PHOTO 1  
SPILLWAY

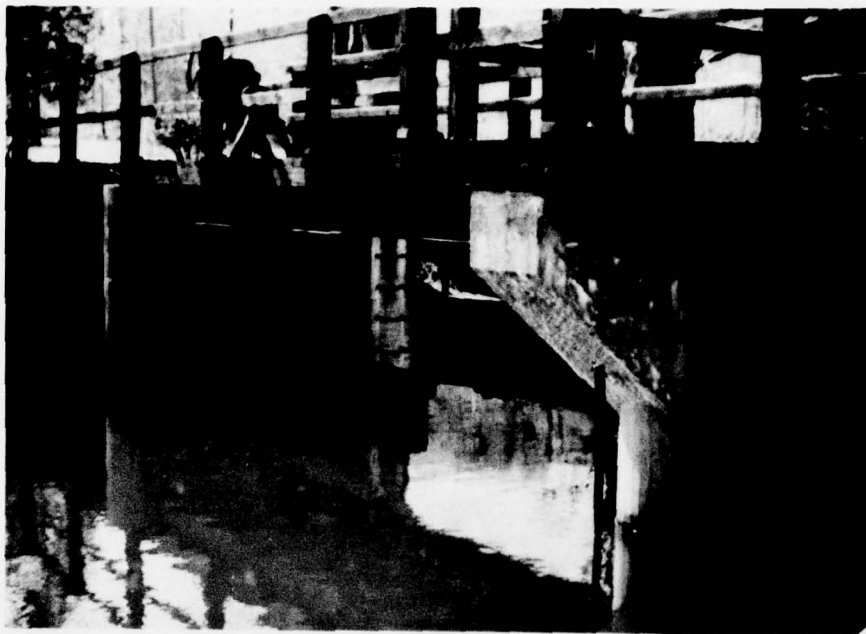
PHOTO 3  
UPSTREAM VIEW OF SPILLWAY

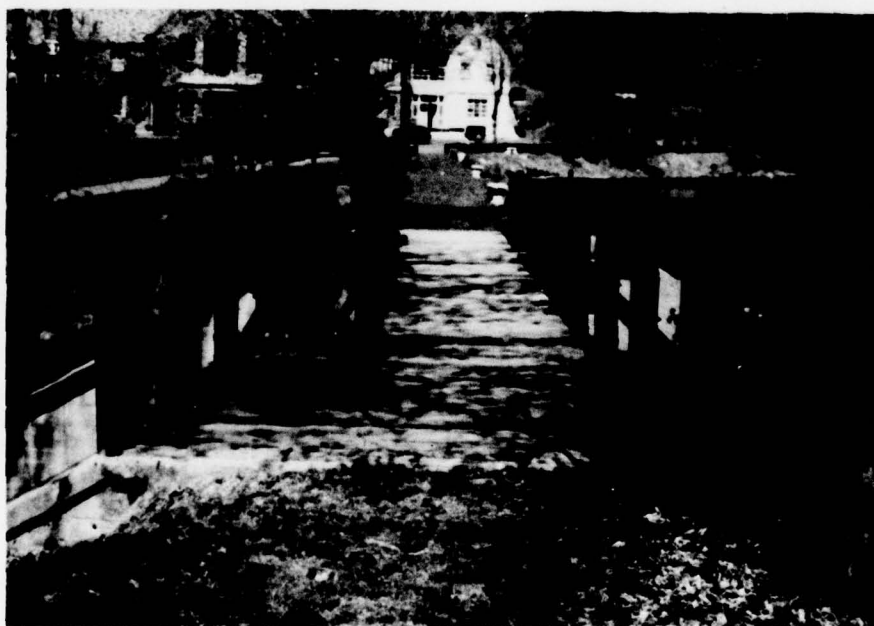
The timber walkway across the spillway also appeared to be in good condition. The operating mechanisms for the radial gates appeared to be in workable condition. The operating stem for one of the abandoned outlet pipes is severely rusted at the water line, although the operating mechanism appeared to be in generally satisfactory condition.

PHOTO 6  
WALKWAY OVER SPILLWAY.  
GATE OPERATING MECHANISM.

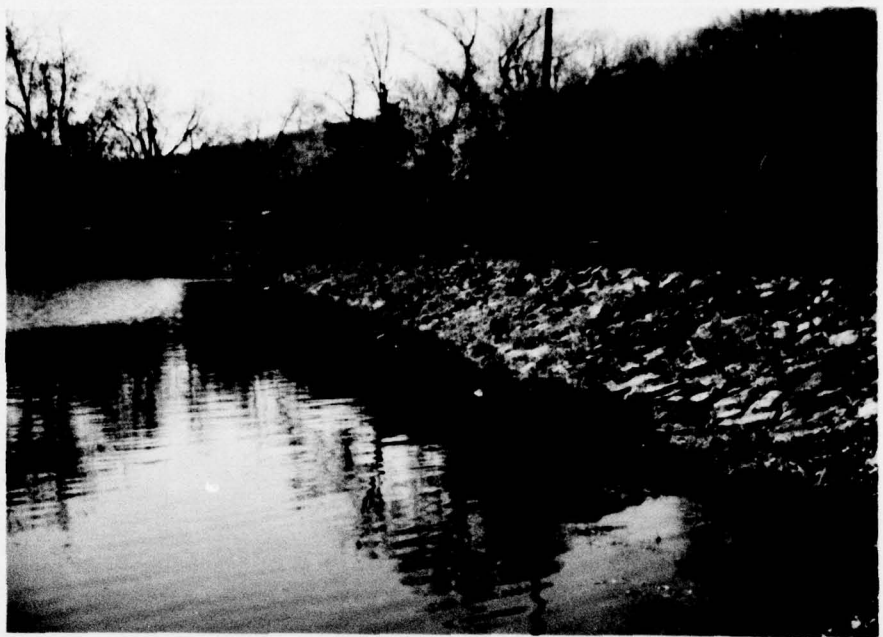
PHOTO 7

UPSTREAM FACE OF DAM

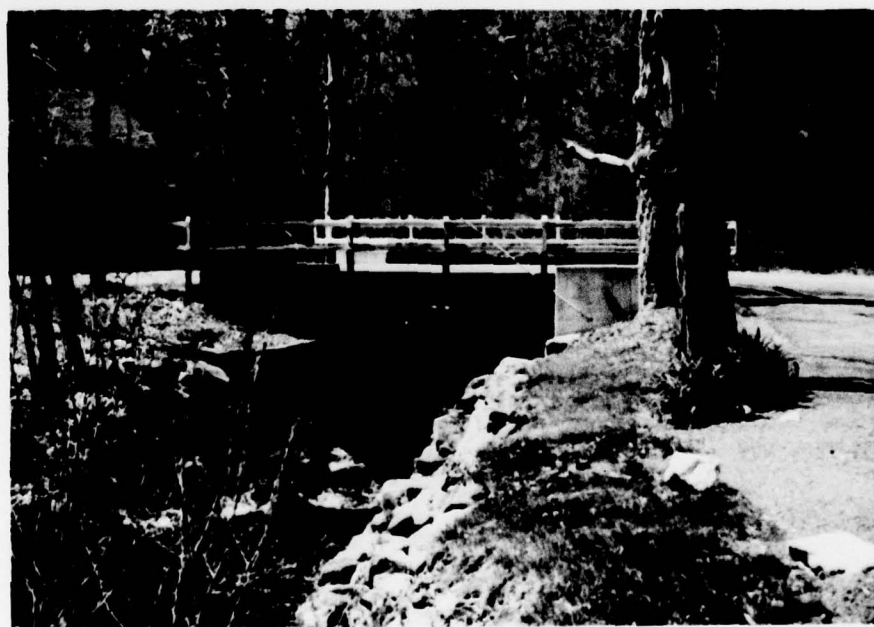
PHOTO 9

One dwelling is located in the downstream flood plain approximately 1800 feet from the dam. The dwelling would be inundated above the first floor as a result of dam failure due to overtopping.

CHANNEL AND ROAD BRIDGE ADJACENT TO DWELLING  
ONE-THIRD MILE DOWNSTREAM FROM DAM
